Coastal processes and shoreline change around Port Townsend: Past, present, and future

Port Townsend Marine Science Center
29 March 2003

Hugh Shipman
WA Department of Ecology

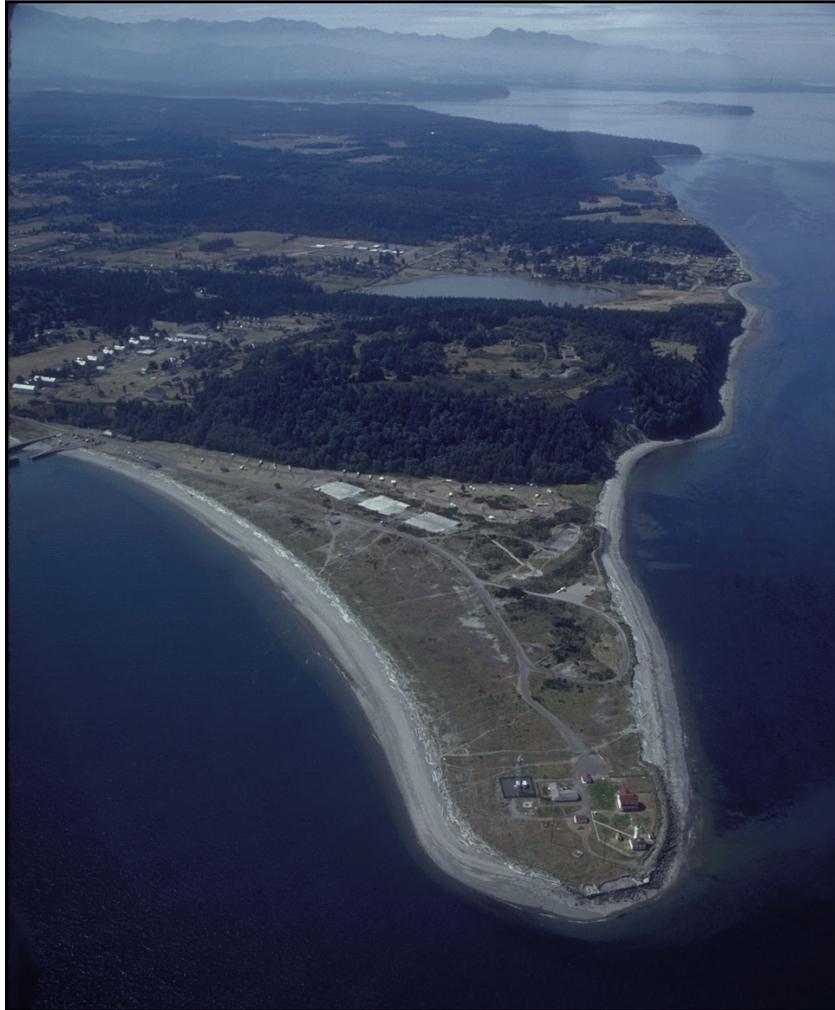
Photo: Gerald Thorsen (mid-1980s)

Geomorphologists classify Point Wilson as a *cusate foreland*. Westerly winds and waves in the Strait of Juan de Fuca transport beach sediment from eroding bluffs between McCurdy Point and Fort Worden to the east, depositing it where the coastline bends sharply south at the entrance of Admiralty Inlet. At the same time, southerly wave action in Admiralty Inlet and Port Townsend Bay moves sediment northward around Point Hudson and along the Chetzamoka Park shoreline toward Fort Worden. The convergence of large volumes of sand and gravel over thousands of years has gradually built Point Wilson.

This photo shows how human efforts to protect the northern side of Point Wilson from erosion have resulted in segmentation of the beach and possible disruption of the natural patterns of sediment movement. Note how the riprap at the lighthouse has turned a smoothly curving beach into a rocky promontory.
